REPORT NO. 710/78

PHOTOGRAPHIC STUDY OF IMPACT  
OF BALL AND ARMOR PIERCING AMMUNITION  
ON ARMOR PLATE

E. L. Reed  
Research Metallurgist

December 21, 1936  
WATERTOWN ARSENAL  
WATERTOWN, MASS.

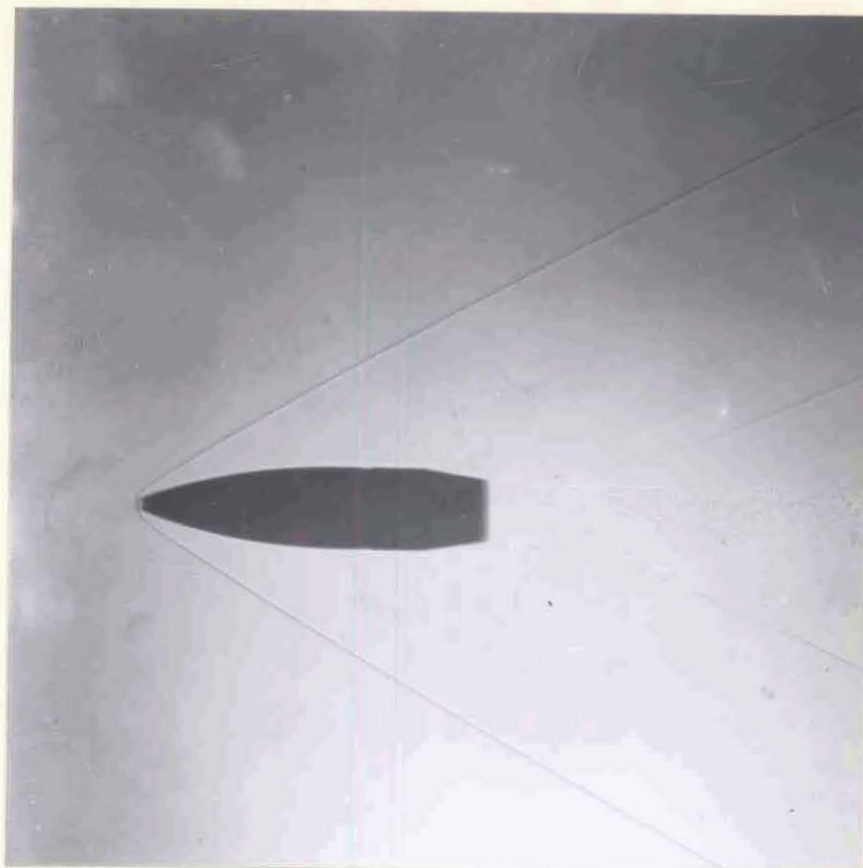
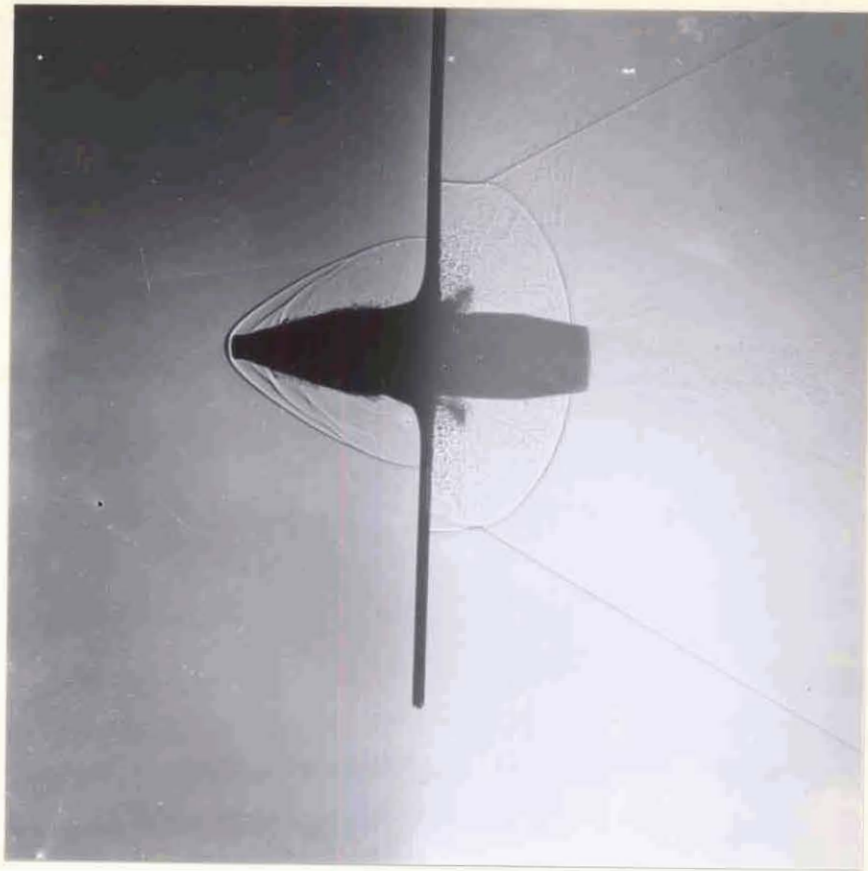
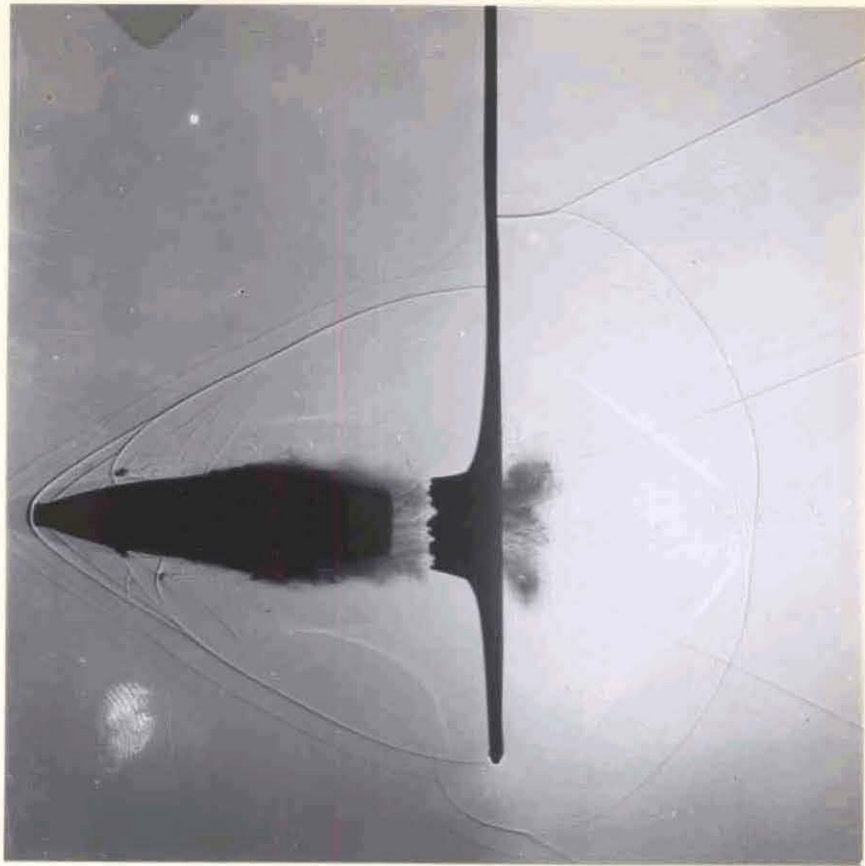
Fig. 2, 3, and 4 illustrate silhouette photographs of Caliber .30 ball ammunition service velocity in flight, during penetration and after penetrating an eighteen gauge aluminum sheet. These photographs illustrate sound waves propagated from the bullet in flight and as they are reflected from the back side of the plate and the start of the new wave as the bullet pierces the plate. These photographs

Silhouette photograph of Cal. .30  
ball service velocity ammunition in flight.

Silhouette photograph of Cal. .30 ball  
service velocity ammunition penetrating an 18 gauge  
aluminum sheet

Silhouette photograph of Cal. .30  
service velocity ammunition after penetrating.

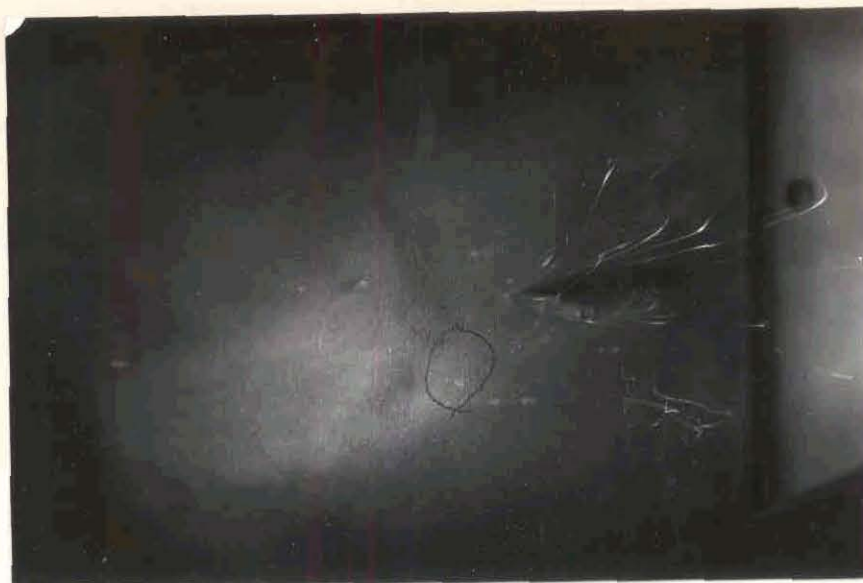
Figure 7 - Photograph by reflected light of Caliber .30 Armor Piercing Service Velocity bullet at the instant of striking Armor Plate. Note flares - probably burning lead. Striking distance 100 yards.

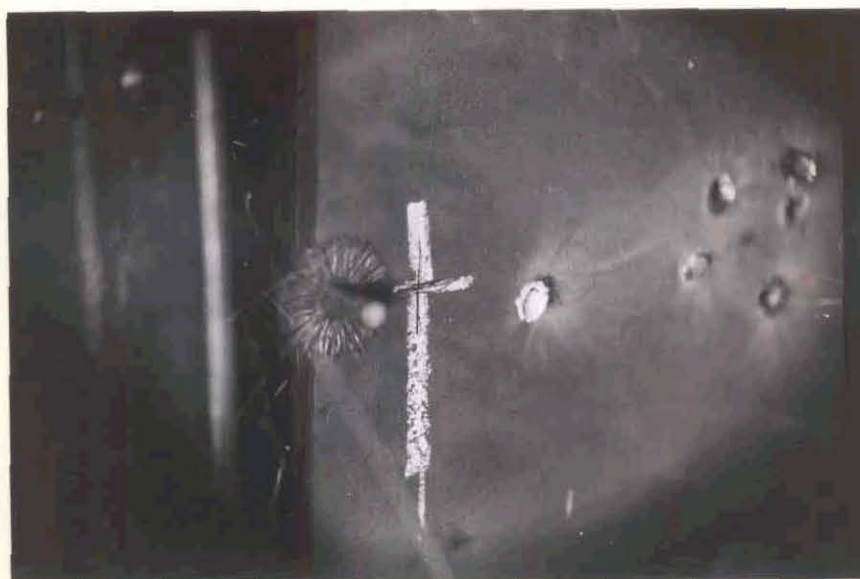
Figure 8 - Photograph by reflected light of Caliber .30 Armor Piercing Service Velocity bullet just striking Armor Plate. Note peeling off jacket metal from bullet core. (striking distance 100 yards).

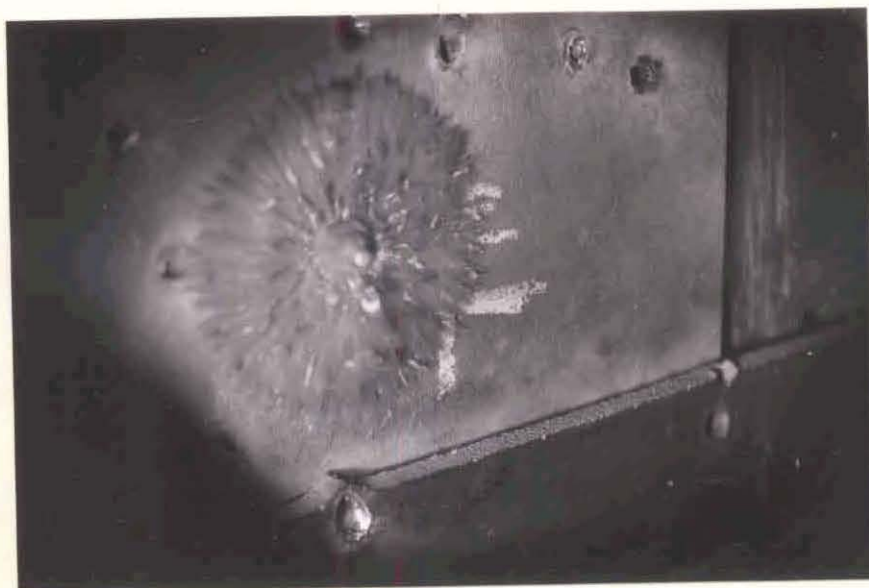
Figure 10 - Photograph by reflected light of Cal..30 Armor Piercing service velocity bullet in progress of penetrating Armor Plate. Note lead splash and particles of jacket metal being blown from impact. (striking distance 100 yards).

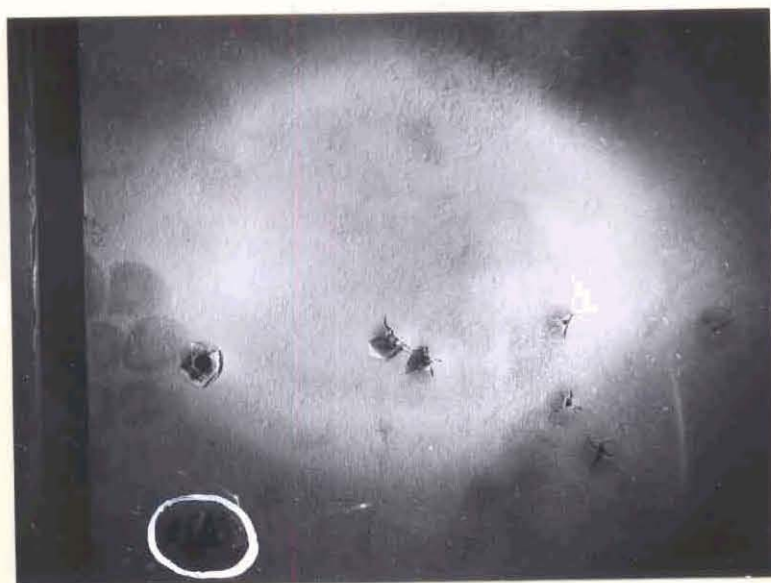
Photographs taken on the back side of the plate before, during, and after impact are shown in Figures 13, 14, 15, 16, 17 and 18. Spalls and incandescent particles are shown flying off the

Figure 14 - Back face during late stage of impact. Spalls flying off and incandescent particles.

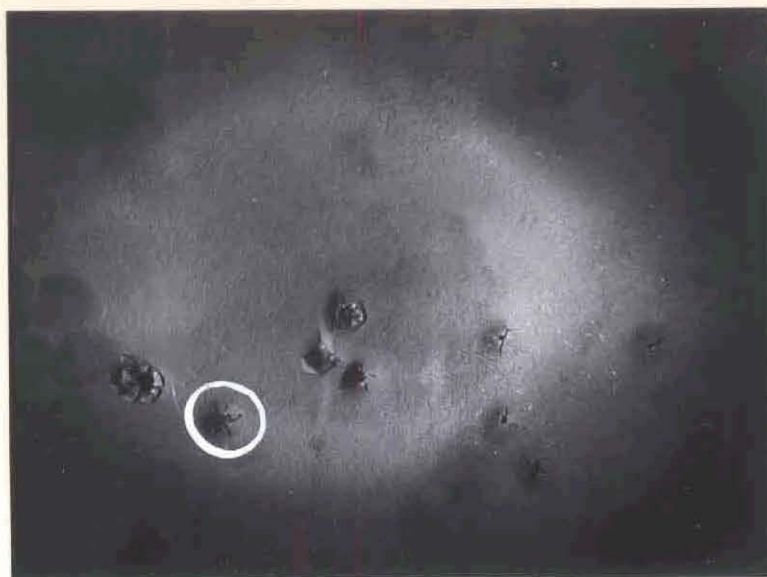
plate in Figure 14. Progress of bullet penetration of the rear face of the plate are illustrated in Figures 17 and 18.

Figure 17 - Back face during impact.  
Nose of bullet core appearing through  
back of plate.

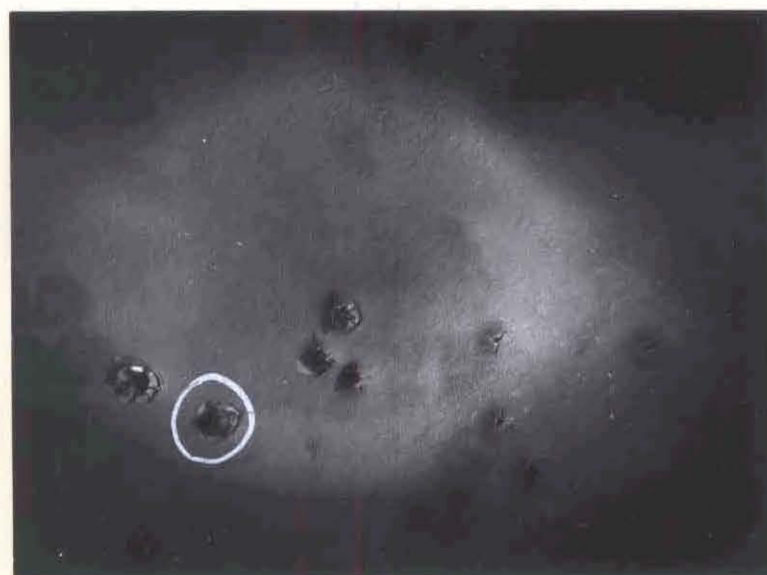
Figure 18 - Back face of plate. Fragments  
blown off. Photographs taken by reflected light.  
Ammunition Caliber .30 Armor Piercing service  
velocity at a distance of 100 yards.

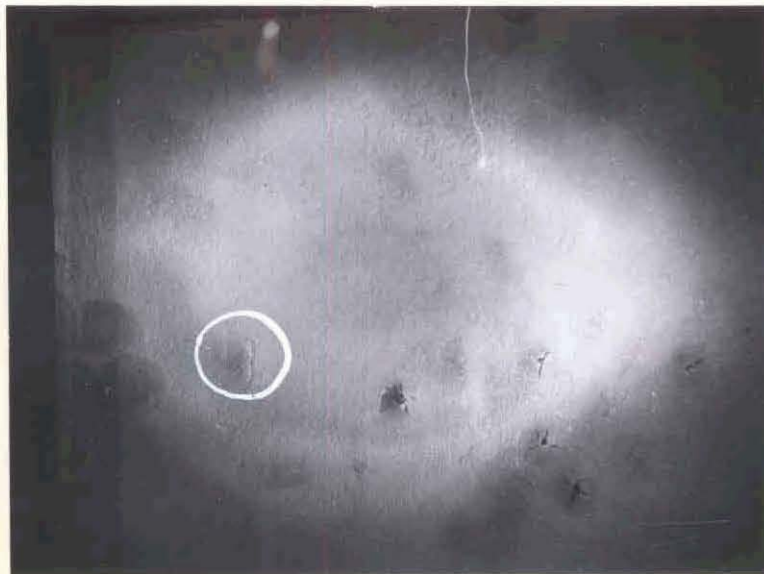
A study of Figure 20 shows slight bulging of metal (within area marked) during early stages of impact. After penetration however, the actual impact, Figure 21, actually occurred 0.5 inches from this bulge. This observation is important in the study of occurrence of elastic deformation during the early stages of bullet impact.

Back face.  
Figure 20 - During early stages of impact.  
Note crack appearing.

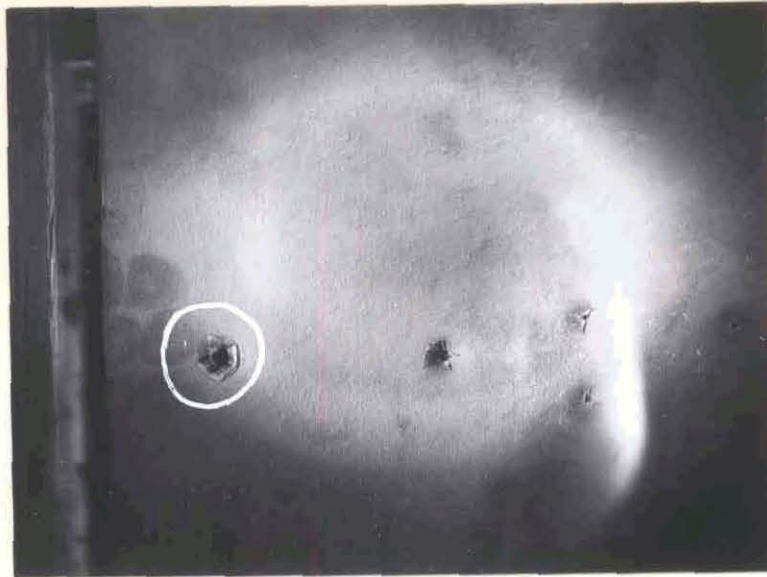
Figure 21 - Back face after impact.  
Photograph taken by reflected light.  
Ammunition - Caliber .30 Armor Piercing service  
velocity at a distance of 100 yards.

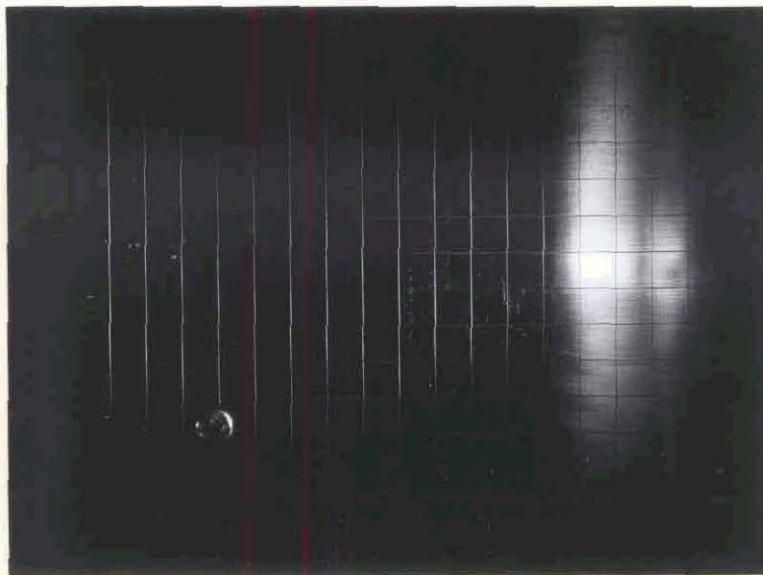
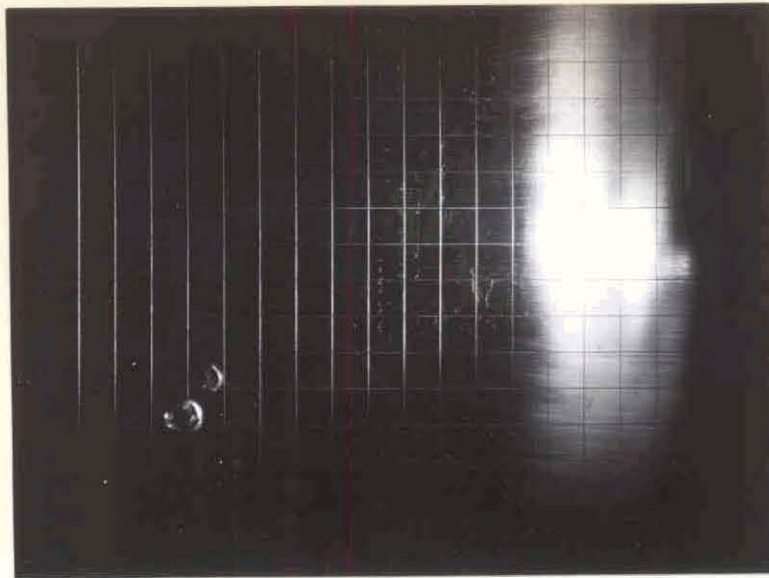
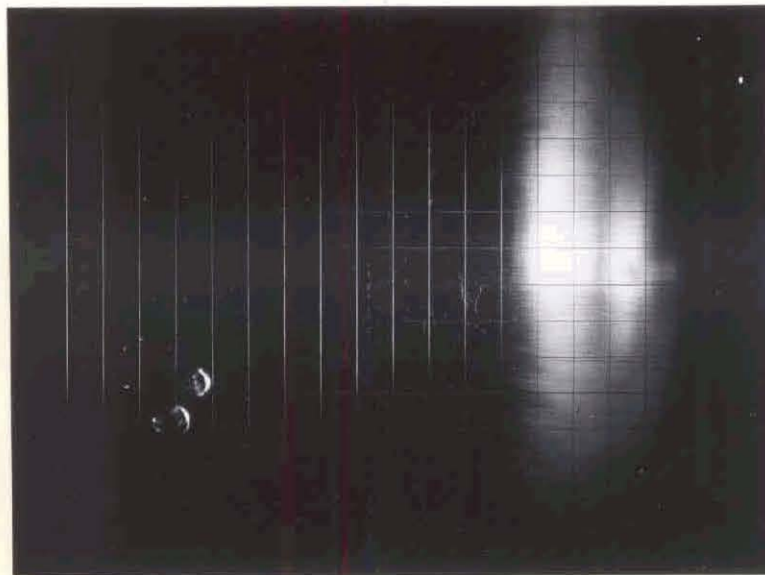
An attempt was made to study the flow of metal after bullet impact on previously polished and ruled back face of a plate. The distortion of the lines near the impact is not pronounced as shown in Figures 22, 23, and 24.

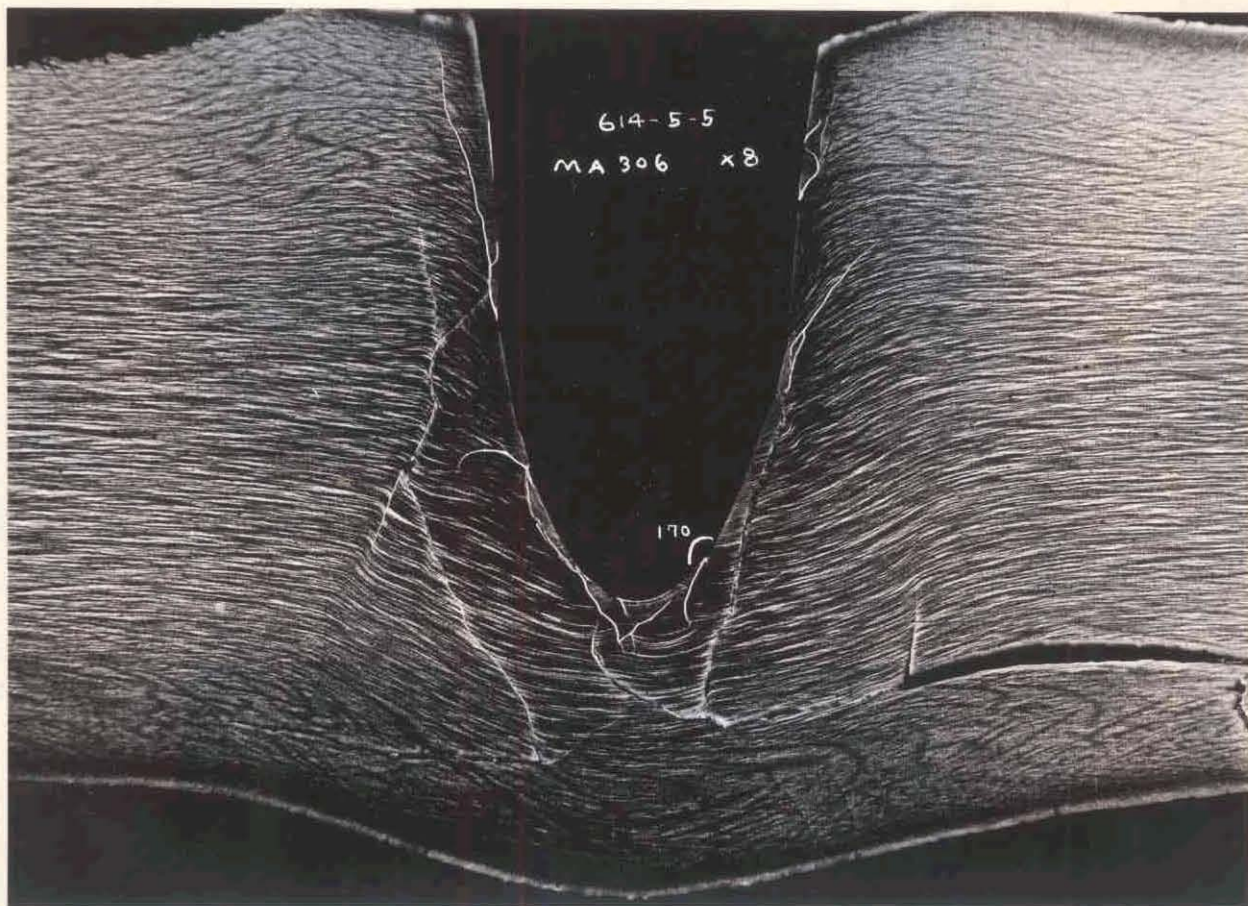
Figure 25

It has been observed recently that in plates of the standard chromium-molybdenum vanadium composition and in other compositions that flow and faulting of the metal occurs in the vicinity of bullet impact, Figures 25 and 26. There evidently has been sufficient

heat generated by the impact of the bullet to cause the metal near the impact to fault or slip along paths of slip of no particular orientation. These slip lines or white layers as they appear in the photographs are harder than the surrounding metal and are believed to be martensitic due to the fact that these paths of slip were heated above the critical point of the metal and quickly cooled by conduction of heat by the surrounding metal.

Macrostructure of cross section of bullet  
hole. C .51%, Cr 1.21%, Mo .56%, Va .29%.  
Etched in Rosenhain-Houghton's Reagent 5X.

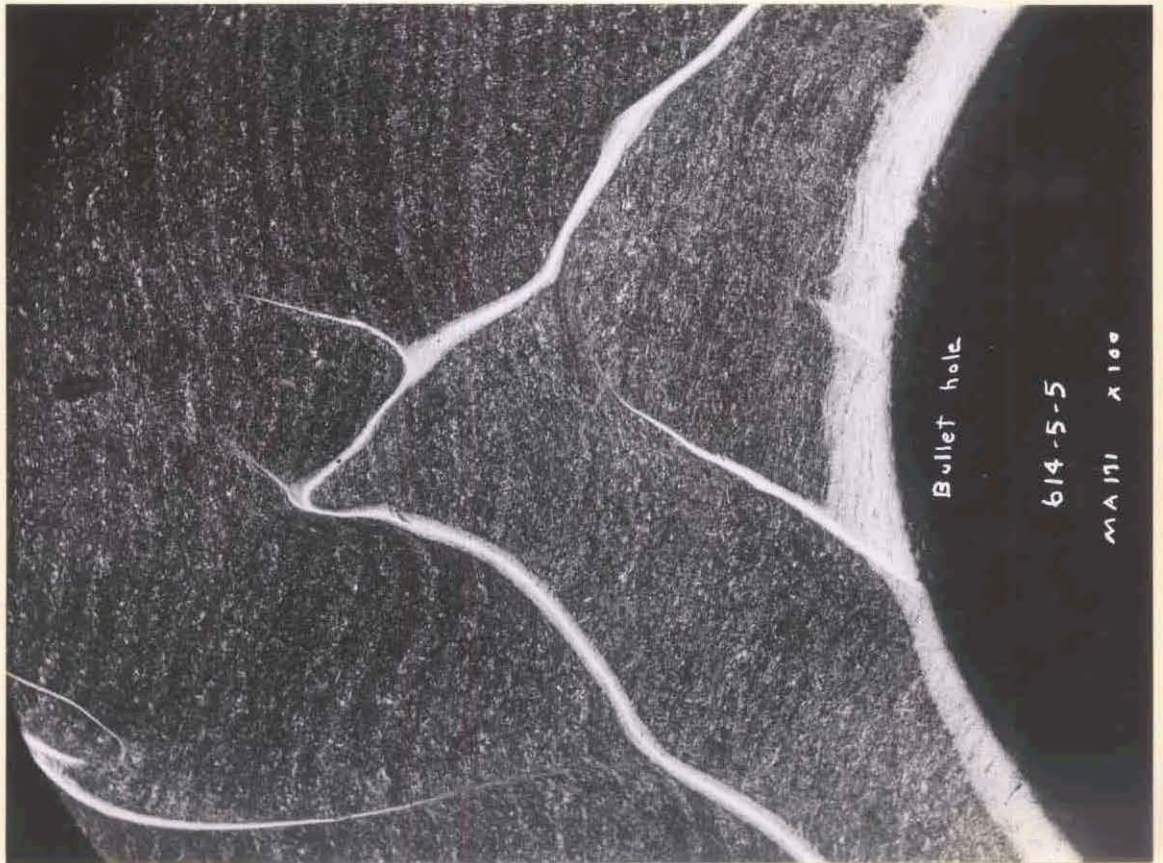
Figure 26

Same as above at bottom of bullet hole.  
Etched in 1% Nital - 100X

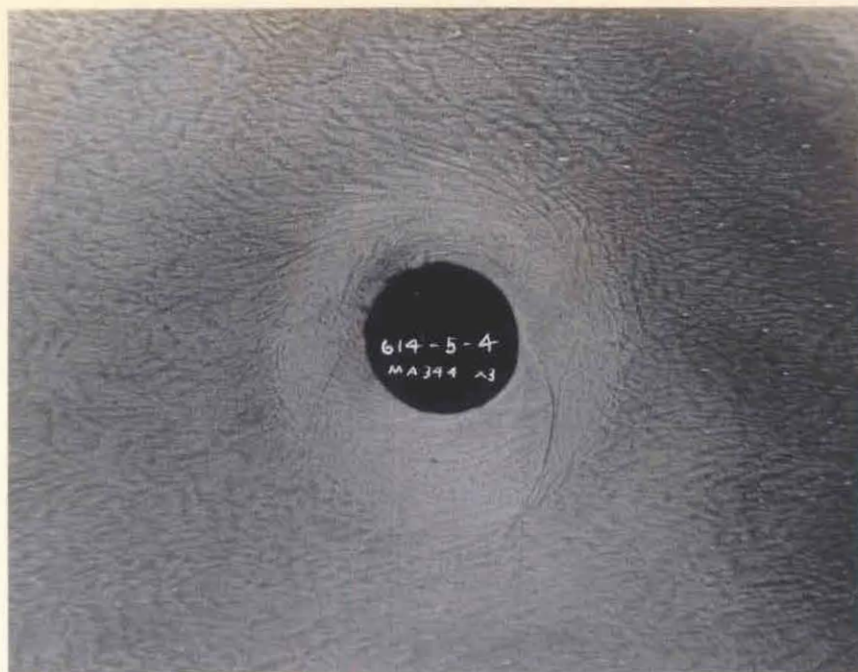
Figure 27 illustrates the flow of metal near the surface of armor plate at area of impact. This structure was revealed about .1 inch below the actual surface of the plate. Evidently the bullet in the early stages of impact may be compared to a high speed boring machine, the heat at time of impact being sufficient to cause torsional flow of metal. In many cases spalls which are blown off the rear face of armor plate show evidence characteristic of torsional flow.

Figure 27 - Macro structure at bullet hole;  
plane parallel to surface. Complete penetration.  
C .51%; Cr 1.21%; Mo .56%; V .29%;  
Etched in Rosenhain-Houghton's reagent - X3

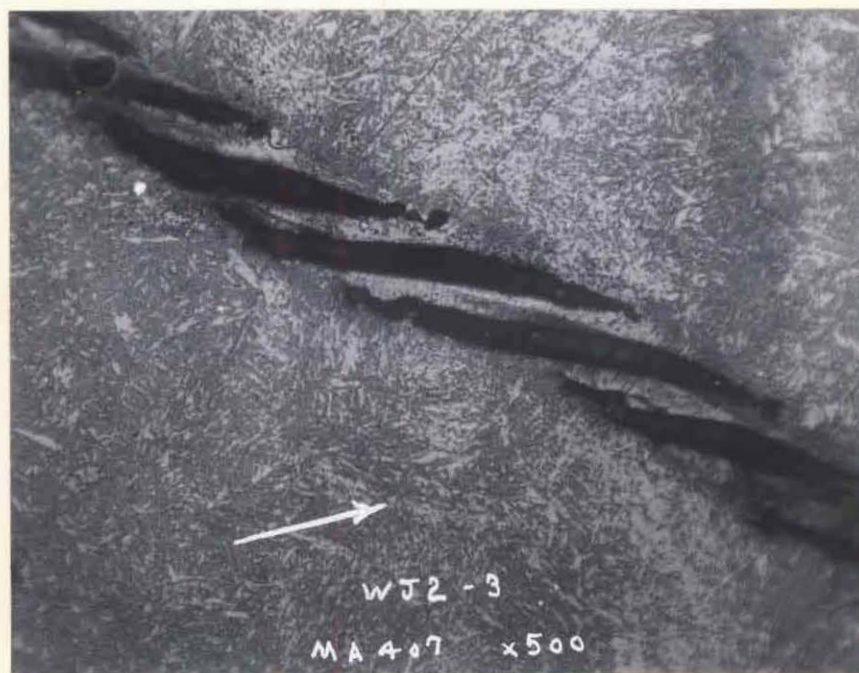
Another case of rupture caused by bullet impact and possibly by torsional flow of metal is shown in Figure 28. This rupture shows actual voids, (black) in the form of well defined twists.

Figure 28 - Micro structure near bottom of  
bullet hole. Arrow indicates bullet penetration.  
C .425; Ni 3.58; Si 2.01. Partial penetration.  
Etched in Sodium Picrate - X1000

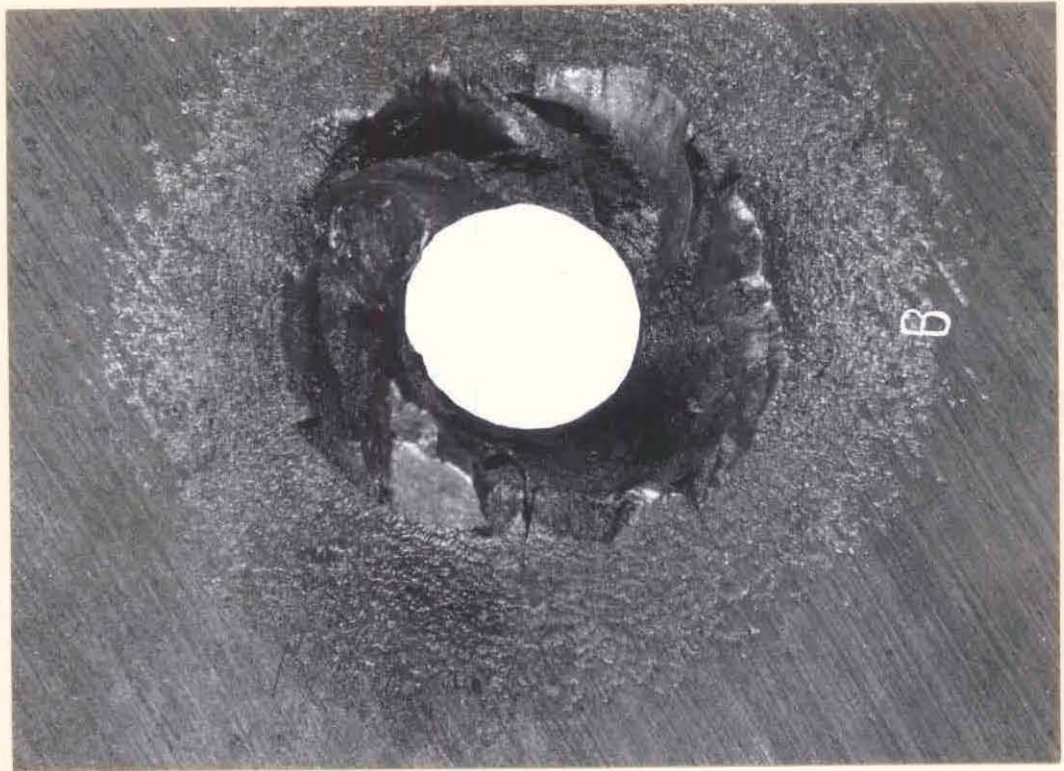
A rear face of a penetrated armor plate, shown in Figure 29 is an example of spalls blown off in a spiral formation, this illustration being suggestive of torsional impact.

Figure 29 - Photograph of rear face of standard chromium-molybdenum-vanadium plate showing evidence of torsional impact; that is, spalls and fragments were blown off in spiral formation X 5.
